# Round Lake Shoreline Survey 2014

*By Tip of the Mitt Watershed Council*

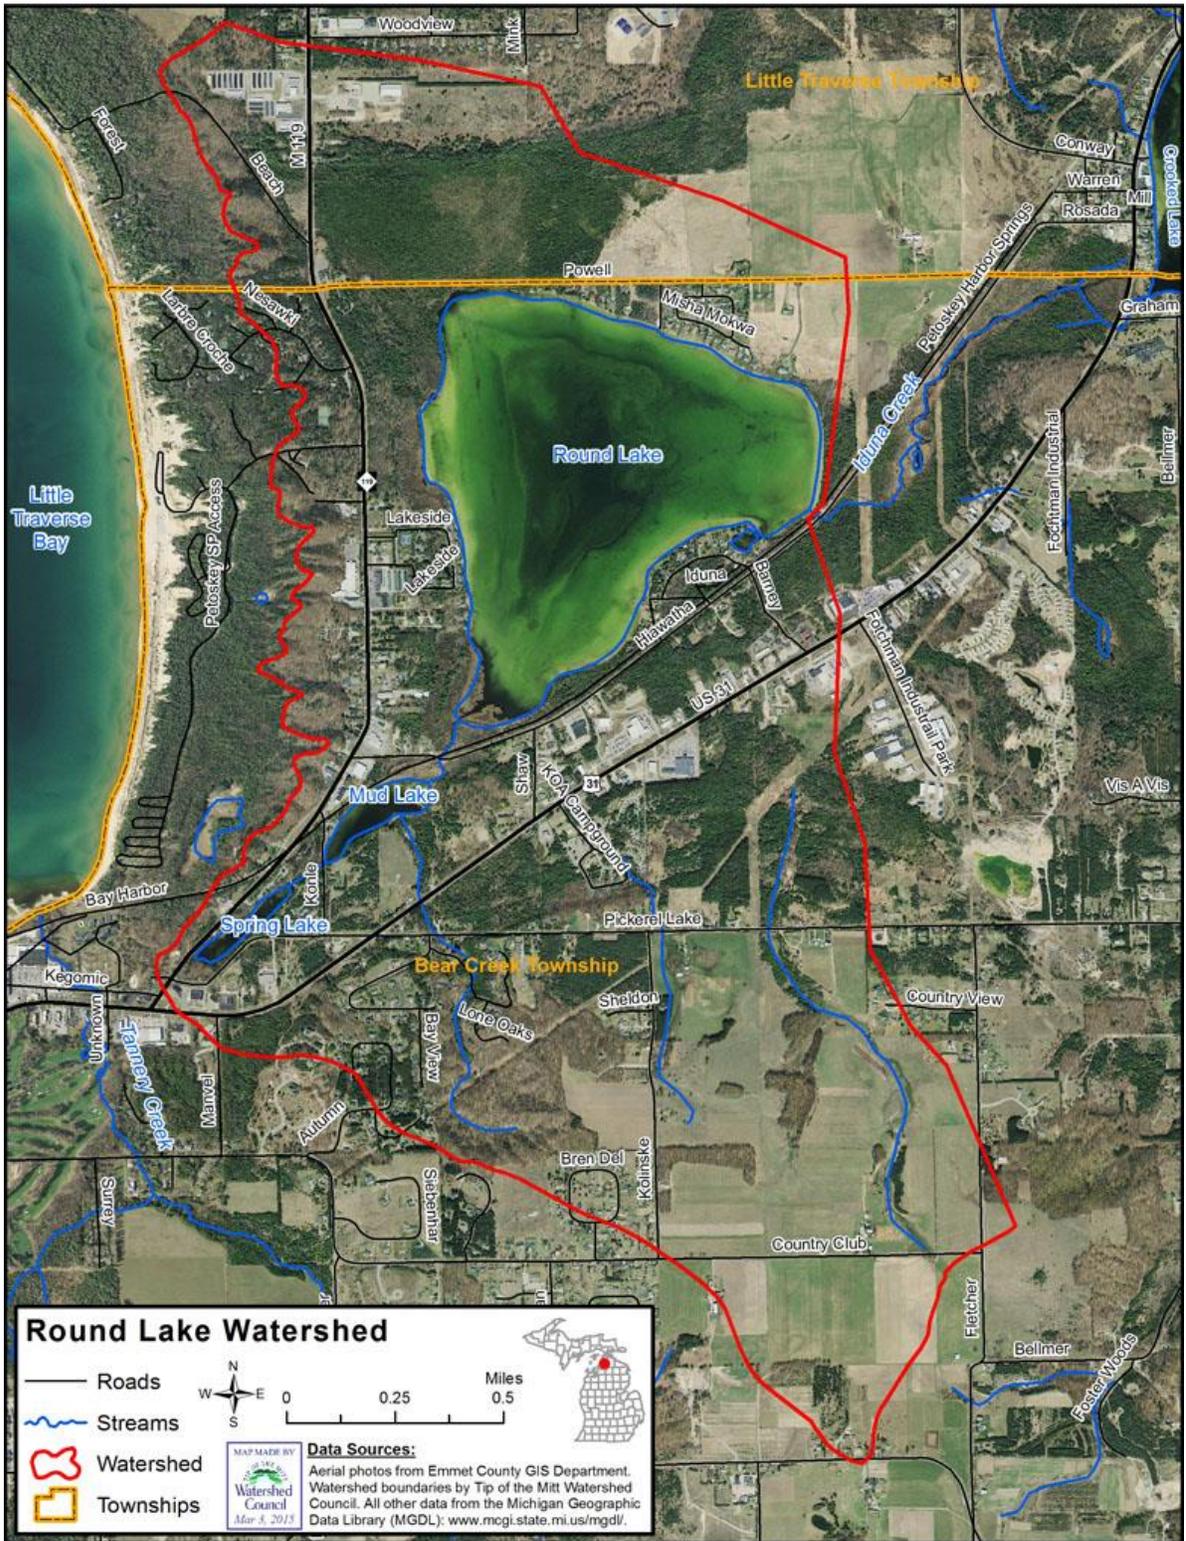
Figure 1. Map of the Round Lake Watershed.

Round Lake is located in the northern Lower Peninsula of Michigan in Emmet County, less than one mile east of Little Traverse Bay. The surface area of Round Lake is approximately 360 acres and the shoreline distance totals four miles (Emmet County GIS, 2012). Round Lake is in northern Bear Creek Township.

Round Lake consists of a single basin in the shape of a rounded equilateral triangle that measures approximately one mile per side. Its deepest location, in the middle of the basin, is 15 feet. Residential development exists along the lake's mid-western, mid-eastern, and mid-northern shorelines, while the rest of the lake is largely undeveloped.

A small unnamed creek limited to 1000 feet in length flows into the southern tip of Round Lake. This inlet tributary delivers water from Mud and Spring Lakes, which receive polluted runoff from adjacent urban development. Iduna Creek is the only outlet, flowing out of Round Lake's eastern terminus and into the east side of Crooked Lake via 1.25 miles of stream channel.

The Round Lake Watershed extends approximately 3.5 miles from near the Harbor Springs Municipal Airport to the north to the top of a morainal ridge along Country Club Road to the east of the City of Petoskey. Large sand dunes in Petoskey State Park limit the watershed's western expansion (Figure 1). The watershed covers 2,367 acres; approximately 400 acres pertaining to the Mud and Spring Lakes Watershed. Most of the Round Lake Watershed is in Bear Creek Township, with the portion north of Powell Road in Little Traverse Township.

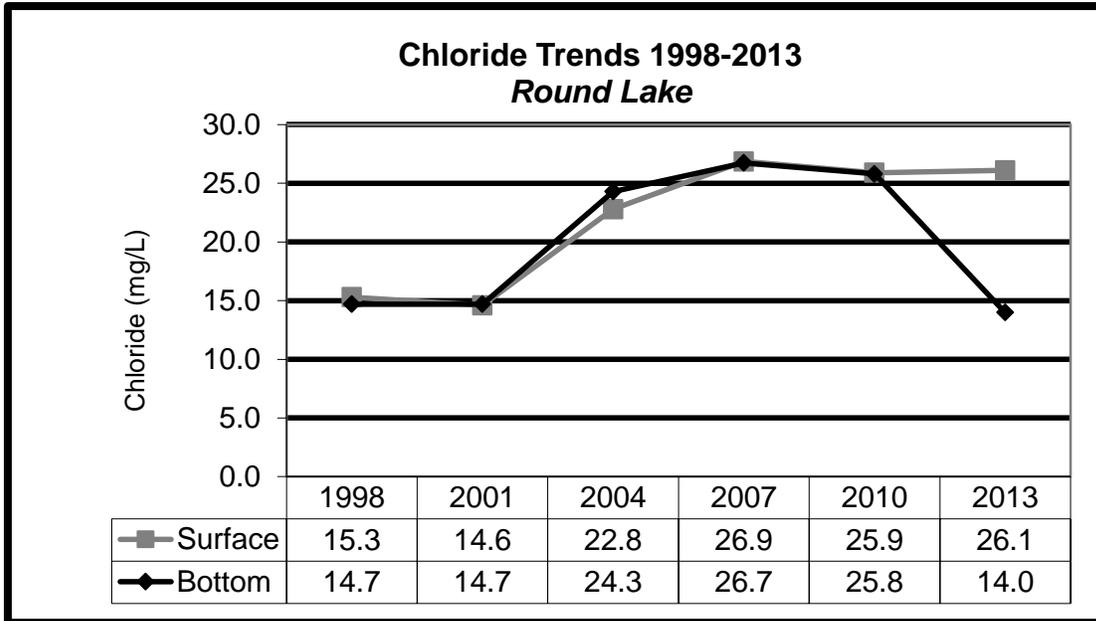
Figure 2. Chloride concentrations in Round Lake.

Based on water quality data collected in programs coordinated by Tip of the Mitt Watershed Council, Round Lake contains high quality waters typical for this region. As part of the Watershed Council’s Comprehensive Water Quality Monitoring Program (CWQM), numerous parameters have been monitored in Round Lake on a triennial basis since 1995. Both dissolved oxygen and pH consistently comply with standards established by the State of Michigan (Table 2). Chloride levels have increased slightly over time, which indicates some degree of impacts from urban, residential and agricultural land use (Figure 2). Typical of high-quality lakes in Northern Michigan, nutrient concentrations on Round Lake are very low. CWQM program data show low phosphorus levels in Round Lake, less than 10 micrograms per liter ( $\mu\text{g/L}$ ), which have declined consistently since 1995 (Figure 3). Phosphorus is found in short supply in Round Lake relative to nitrogen and therefore, limits the amount of algae and plant growth that occurs in the lake.

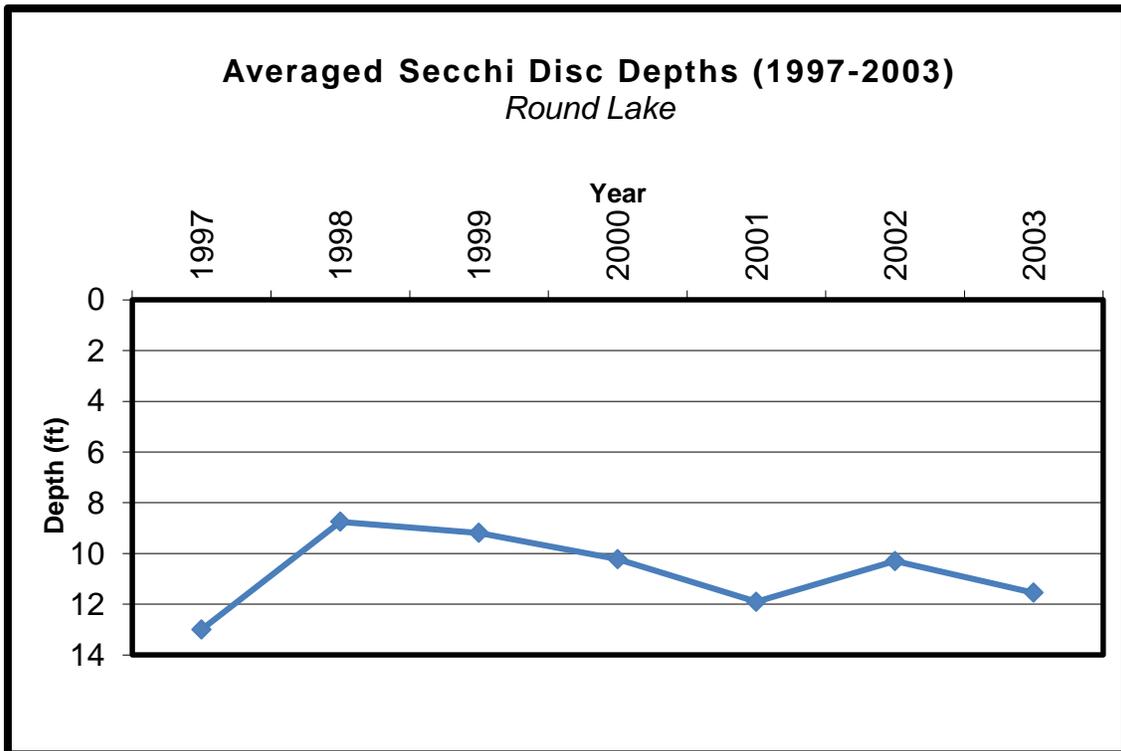
Figure 4. Water transparency in Round Lake.

Data from Tip of the Mitt Watershed Council’s Volunteer Lake Monitoring Program show Round Lake to be a moderately productive lake. Water clarity was fairly stable

during the period it was monitored, ranging from 9 to 13 feet (Figure 4). Trophic Status Index values calculated using water clarity data from 1997 to 2003 ranged from 40-46, indicating that Round Lake is mesotrophic (Figure 5). Mesotrophic lakes are characterized as having moderate amounts of dissolved nutrients, which typically results in moderate biological productivity in terms of aquatic plants, invertebrates, and fish.

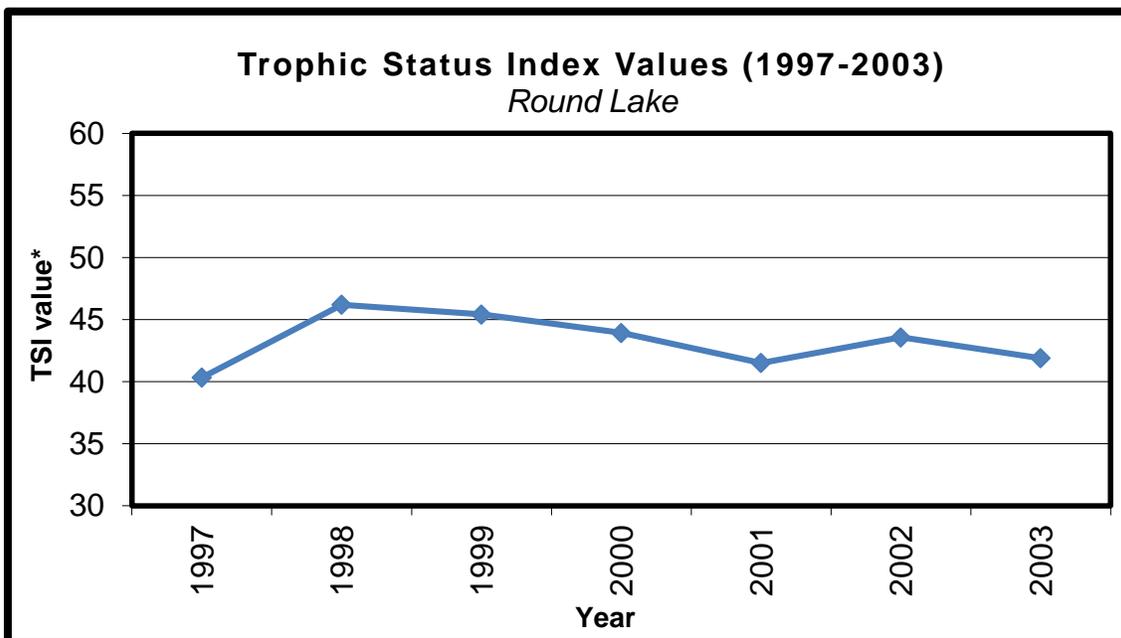
Figure 5. Trophic Status Index values for Round Lake.

\*0-38 = oligotrophic or low productive system, 39-49 = mesotrophic or moderately productive system, and 50+ = eutrophic or highly productive system.

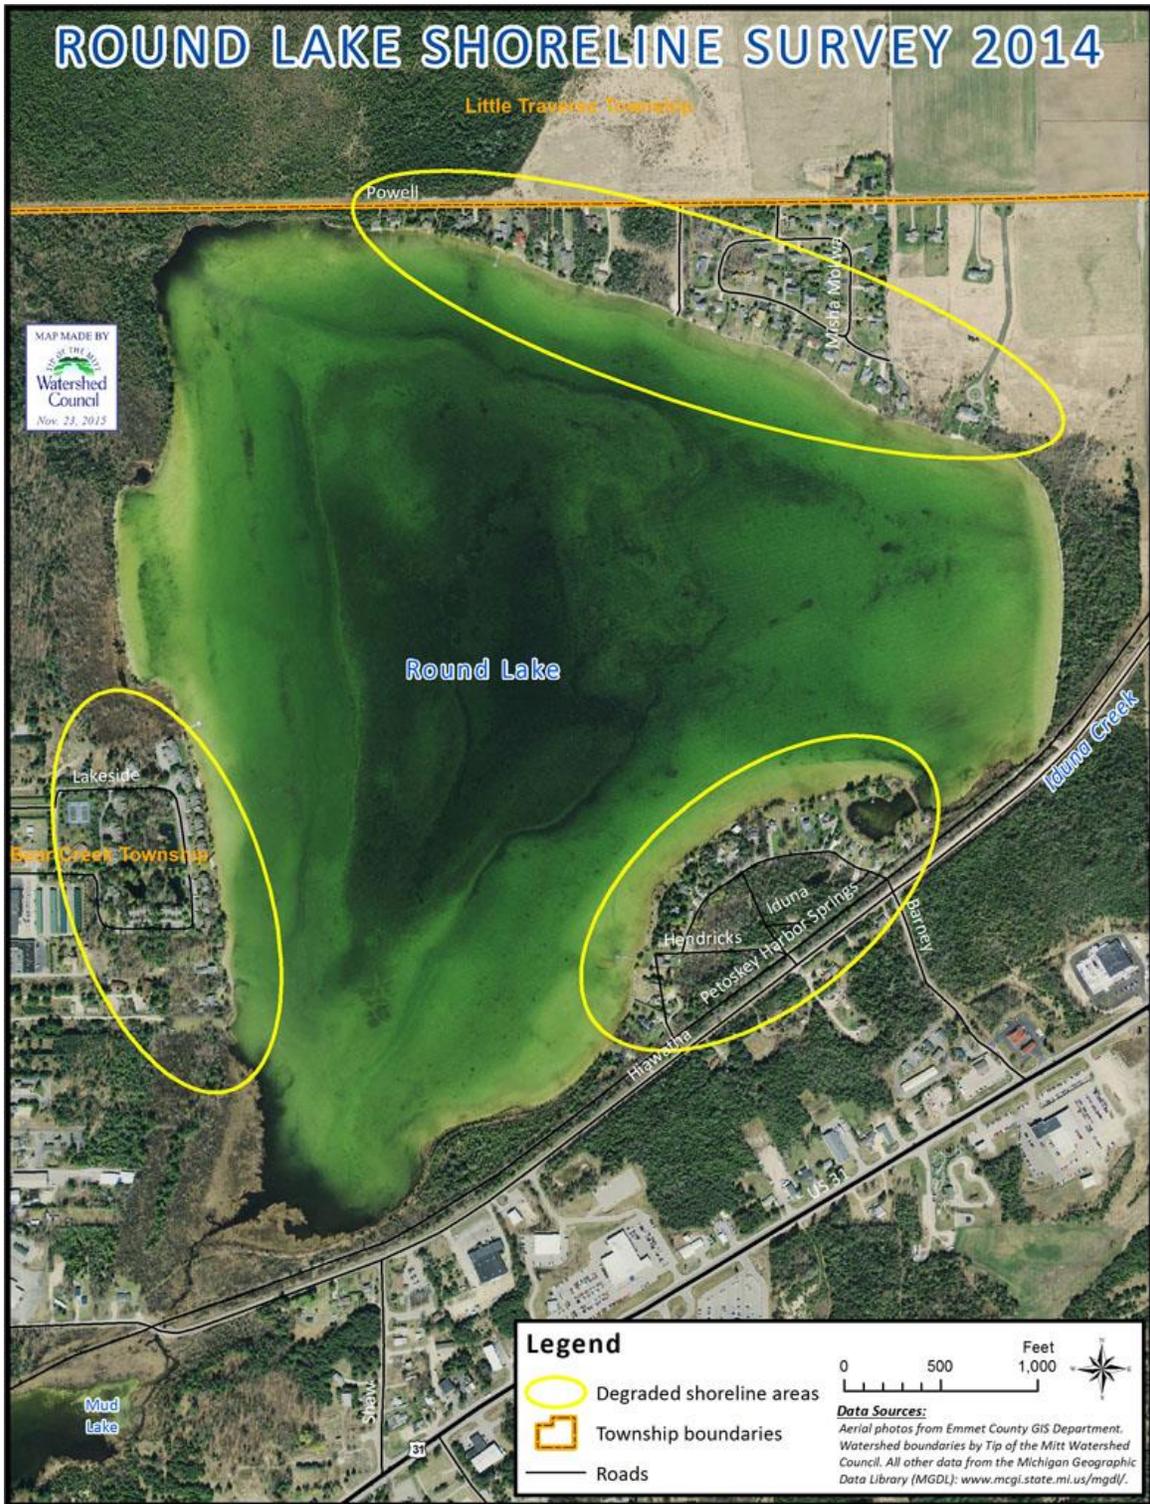
Figure 6. Survey results: degraded shoreline areas.

Maps were developed to display and examine patterns in the occurrence of *Cladophora* growths, erosion, and poor greenbelts on the Round Lake shoreline. All properties with observed *Cladophora* growth occurred on the northern shore of the lake, with the heaviest growth occurring to the west of the MDNR boat launch. Clusters of properties with moderate to severe shoreline erosion were found in the three developed lakeshore areas, toward the middle of the north, west, and southeast shorelines (Figure 6).

Groupings of properties with shoreline alteration and poor greenbelts corresponded with those of erosion sites.

4. Confidentially inform owners of properties with moderate to heavy *Cladophora* growths, moderate to severely eroded shorelines, and poor or very poor greenbelt scores of specific results for their property. Encourage riparians to work with the Watershed Council to identify and correct problems. Send riparians a questionnaire to fill out and return (or make available electronically) to help interpret causes of the growth and provide recommendations for addressing problems. If property owners need further assistance, they can contract with the Watershed Council or other qualified organizations or businesses to perform site assessments to evaluate and remedy problems with nutrient pollution, erosion, and greenbelts.
